Mr. Robert Pignato
National Candle Association
529 14th Street NW, Suite 1280
Washington, DC 20045

Re: **Test Report**
Coated and Botanical Candles
Candles Manufactured for Testing Purposes Only
by NCA Member Companies

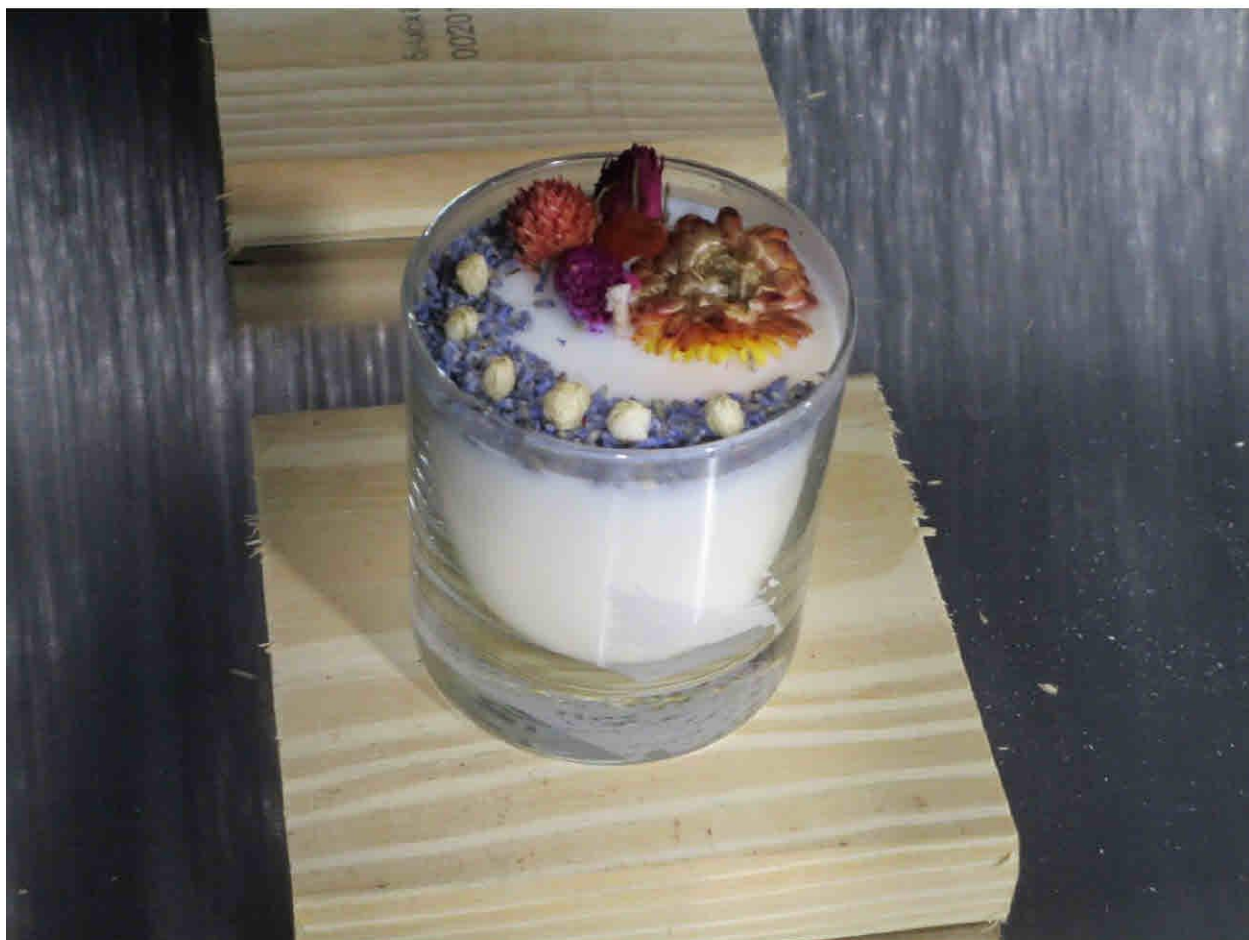
Sample 1: This candle was manufactured for “testing only” by the Sample 1 Company. The candle consisted of a filled candle, with dried botanical material on the surface. There were flower petals within close proximity of the candle’s wick, such that it was nearly impossible not to light the botanicals when lighting the candle. Figure 1 documents what the candle looked like prior to testing. Shortly after the candle was lit, the botanical features ignited and acted as a secondary ignition source. Within the first hour of the candle burning, the wax had become so hot from the secondary ignition of the botanicals that the wax itself ignited and the candle experienced a flashover event. **Figure 4** shows the beginnings of the secondary ignition of the candle shortly after it was lit. **Figure 5** documents the progression of the secondary ignition event. **Figure 6** documents the candle once it had flashed over and the entire surface of the wax was on fire.

Figure 1: Photograph of candle supplied by Sample 1 Company for testing.

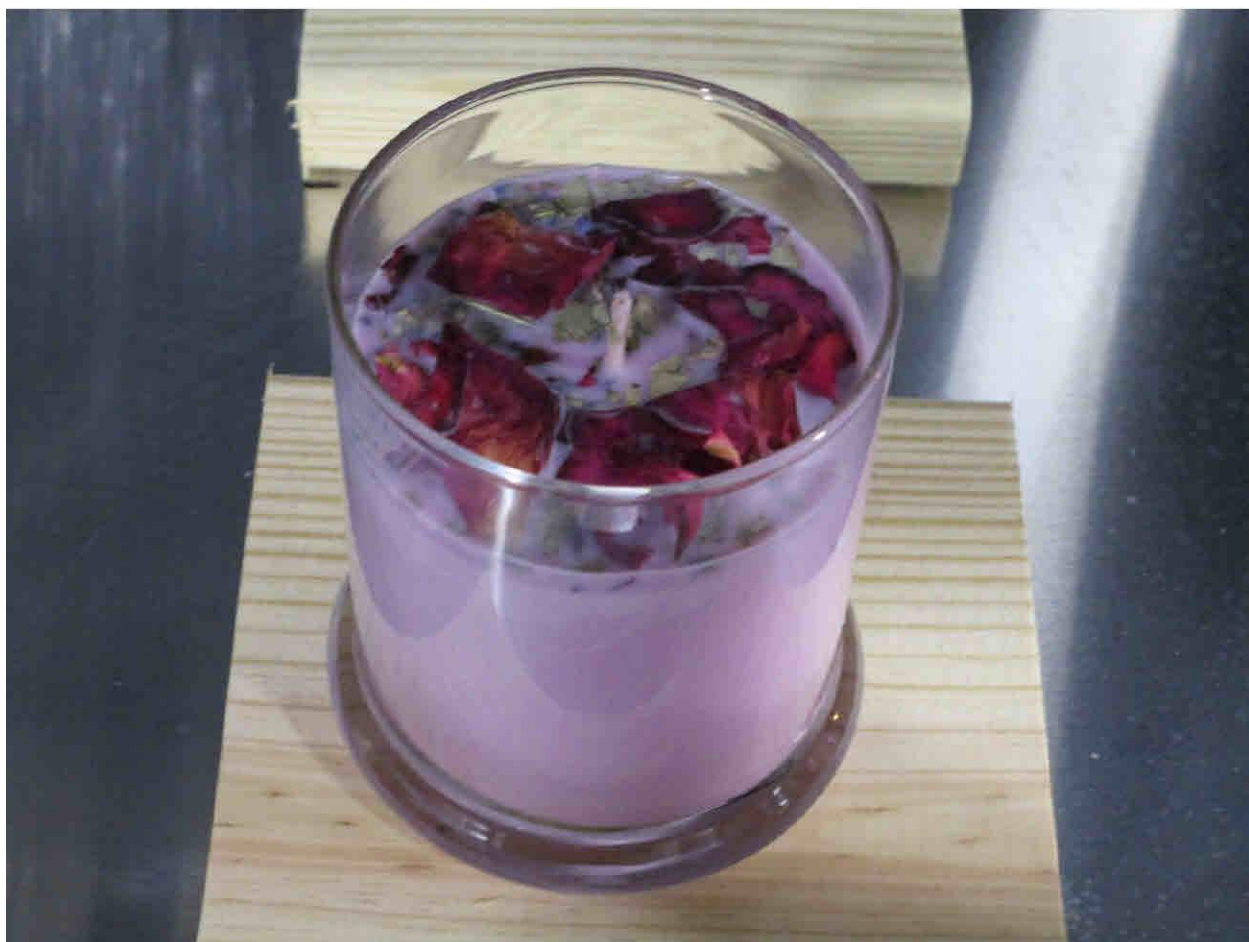
Sample 2: This candle was manufactured for testing only by the Sample 2 Company. The candle was a single-wick candle in a glass container, with botanical material on the surface. This candle was burned in four-hour burn cycles in accordance with ASTM F-2417. No secondary ignition events were observed throughout the candle’s burn life.

Figure 2: Photograph of candle supplied by Sample 2 Company for testing.

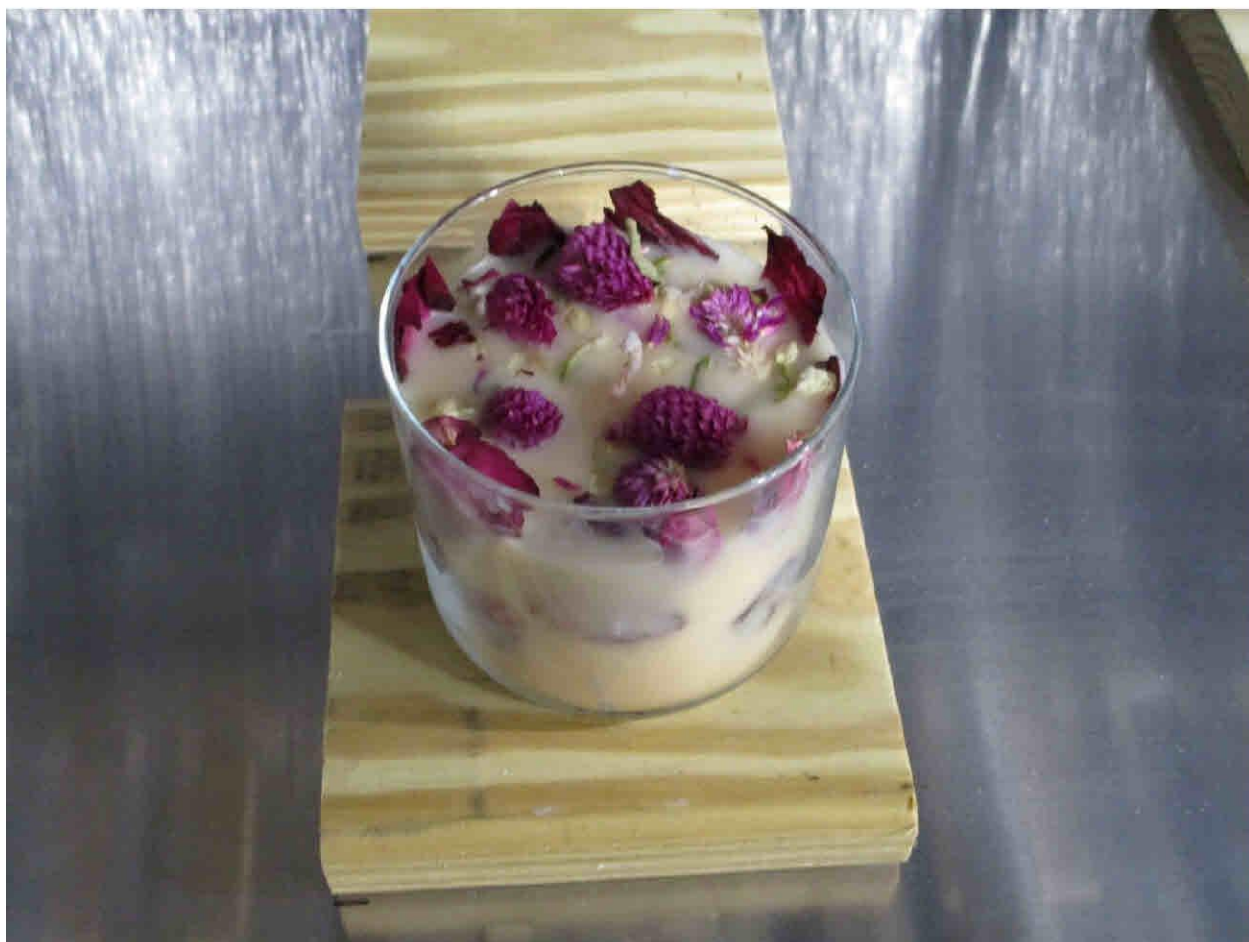
Sample 3: This candle was manufactured for testing only by the Sample 3 Company and was also a single-wick candle in a glass container, with botanical materials on the surface and imbedded in the candle wax, as seen in Figure 3. This candle experienced a secondary ignition event of the botanical materials the first time the candle was burned. **Figure 7** documents this secondary ignition event. Testing of the candle continued, and the candle was burned in four-hour burn cycles per the ASTM F-2417 test method. The candle continued to experience secondary ignition events as it burned; however, it did not experience a flashover event. The candle’s wick eventually drowned, as the secondary ignition of botanicals in the candle created a large melt pool causing the flame on the primary wick to extinguish. **Figure 8** shows the candle when the primary wick was drowned out and only the botanical material remained lit.

Figure 3: Photograph of candle supplied by Sample 3 Company for testing.

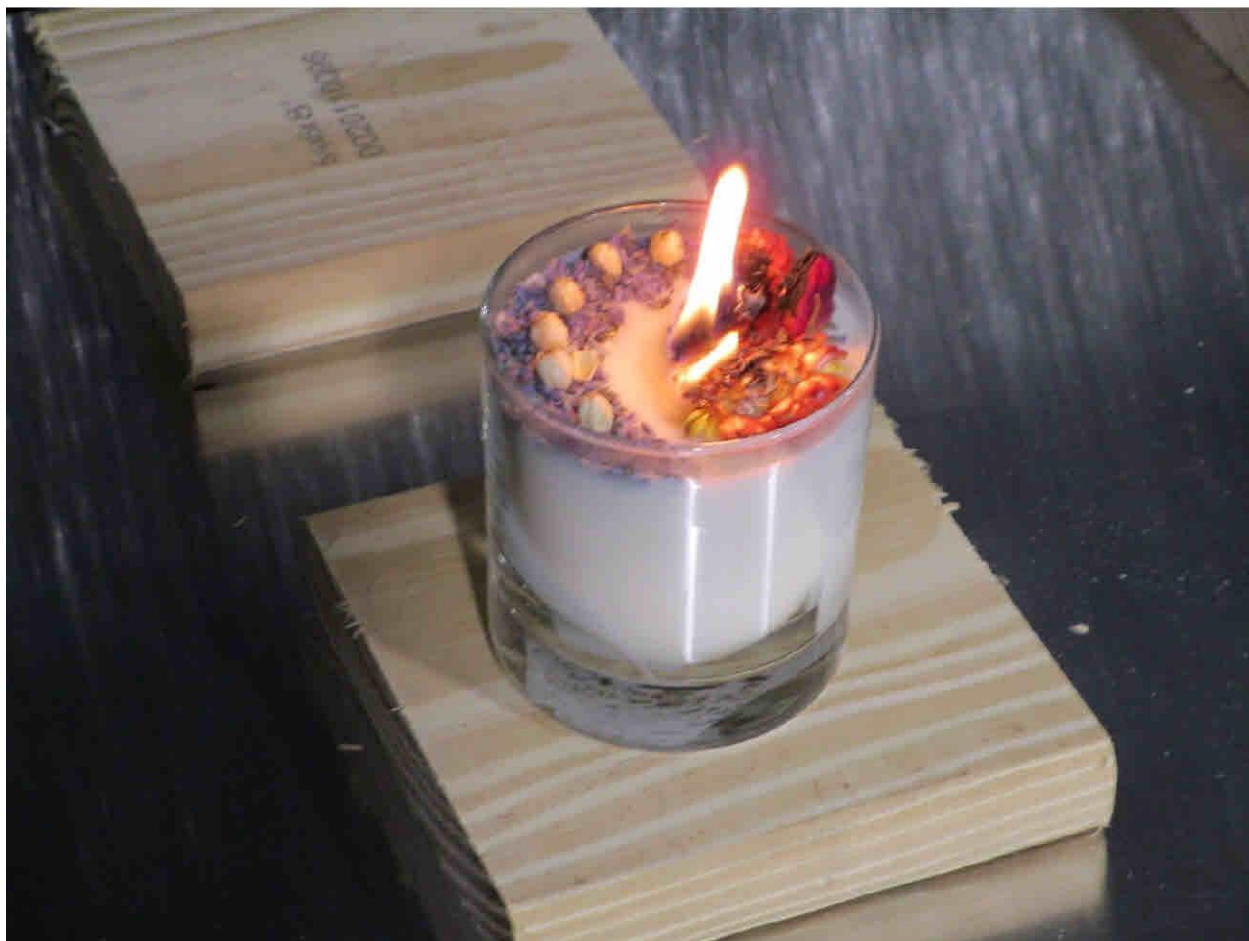
Figure 4: Sample 1 Company candle shortly after lighting. Dried flower has ignited and is supporting combustion.

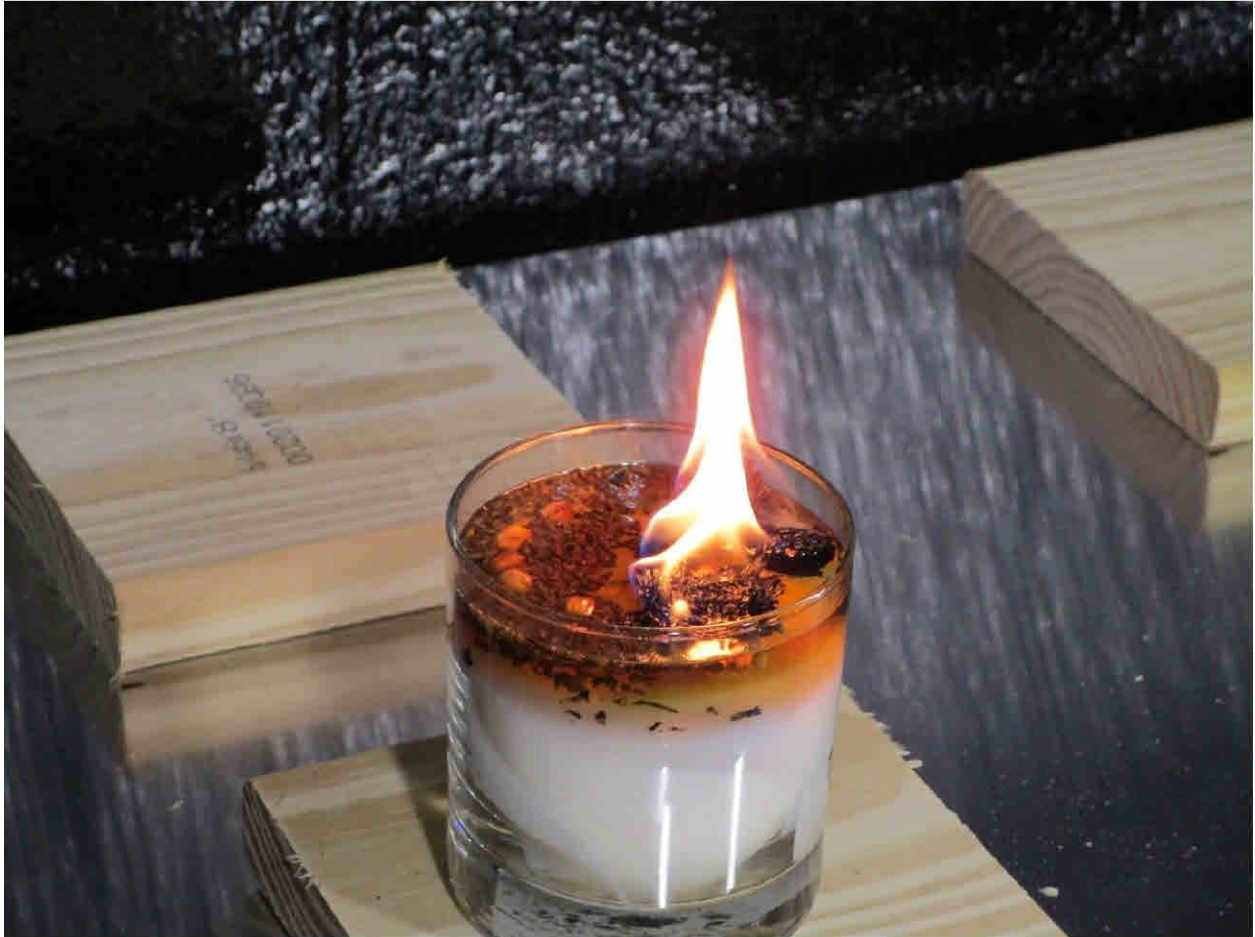
Figure 5: Sample 1 Company candle with secondary ignition progressing. Wax pool is becoming deep.

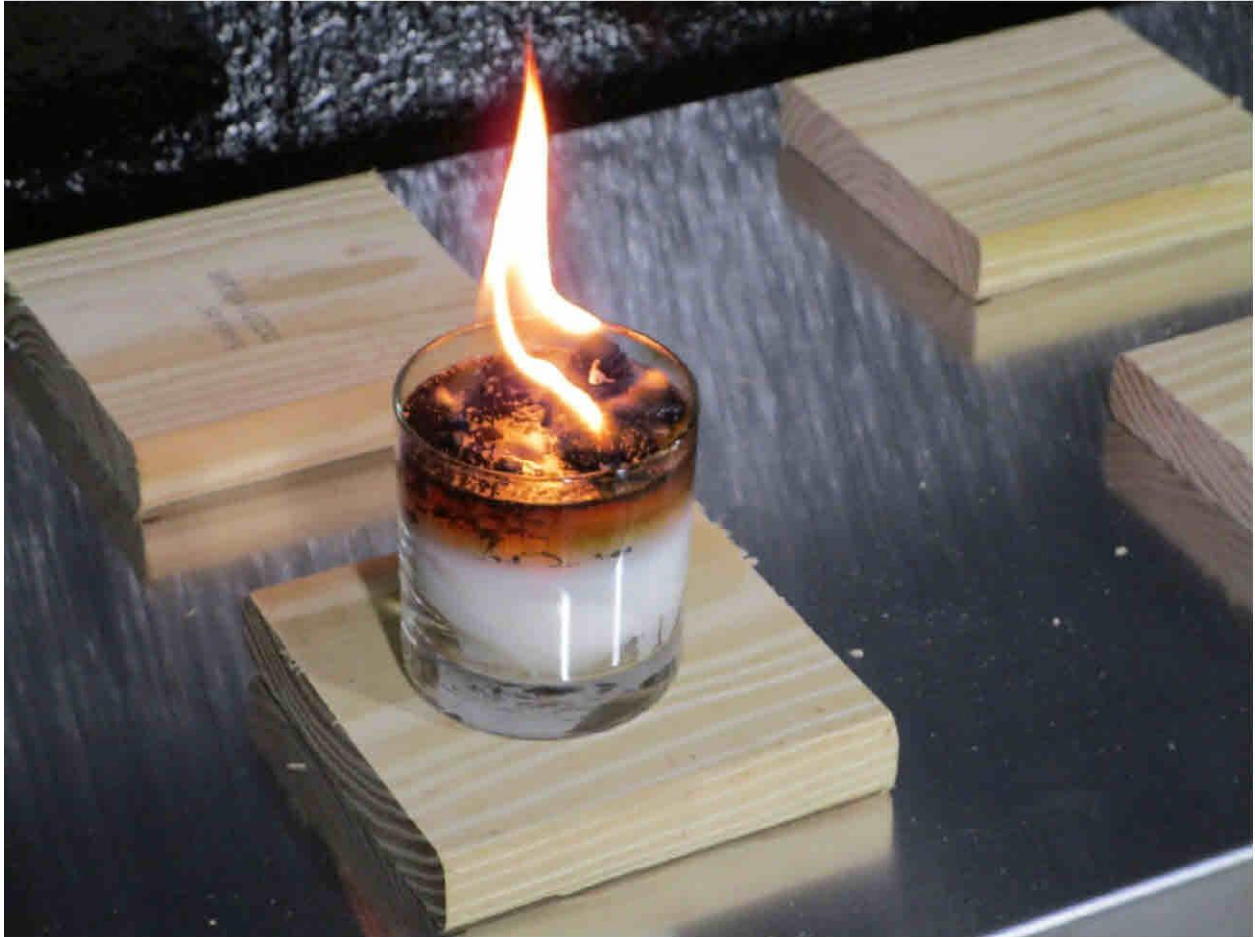
One of the secondary ignition events, specifically the one observed on the candle produced by the Sample 1 Company for this experiment, was so intense that it caused the candle to experience a flashover event where the entire surface of the wax ignited.

It should be further noted that when a candle experiences a flashover event, such as sample 1, the addition of water to extinguish the candle fire can create a much worse situation. When water is added to a candle fire, it is like adding water to a grease fire. When the water hits the flaming hot wax, it vaporizes, which creates large flames that are carried with the steam that is emitted due to the addition of water to the candle fire. Should a candle experience a flashover, the safest way to extinguish the fire is to smother it with a pot or some other device and starve the fire of oxygen. For safety reasons, a candle flashover event should never be extinguished with water.

Figure 6: Sample 1 Company candle. Within 50 minutes of lighting, candle experienced flashover where entire surface is on fire.

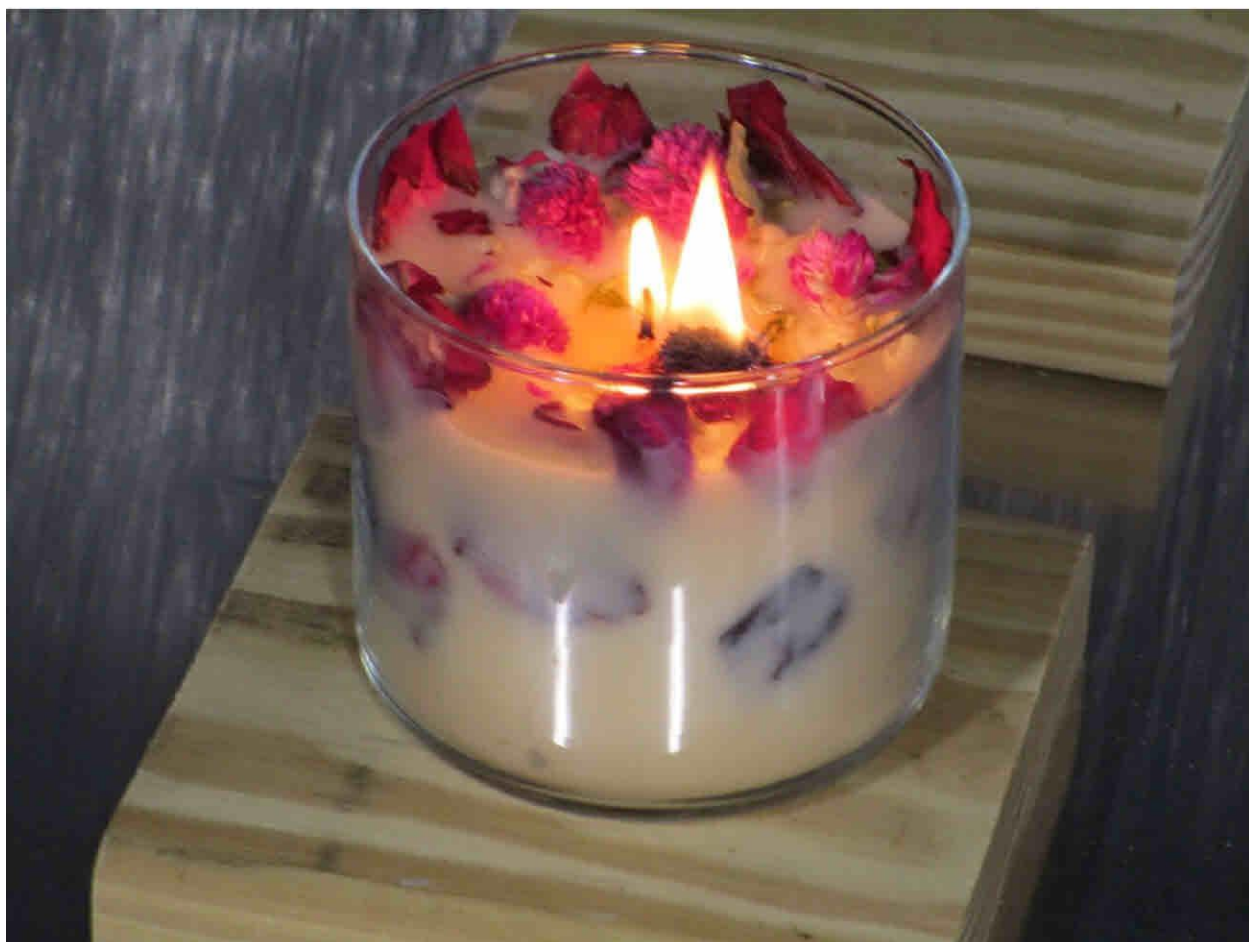
Figure 7: Sample 3 Company candle, with secondary ignition of botanicals, during first four-hour burn cycle.

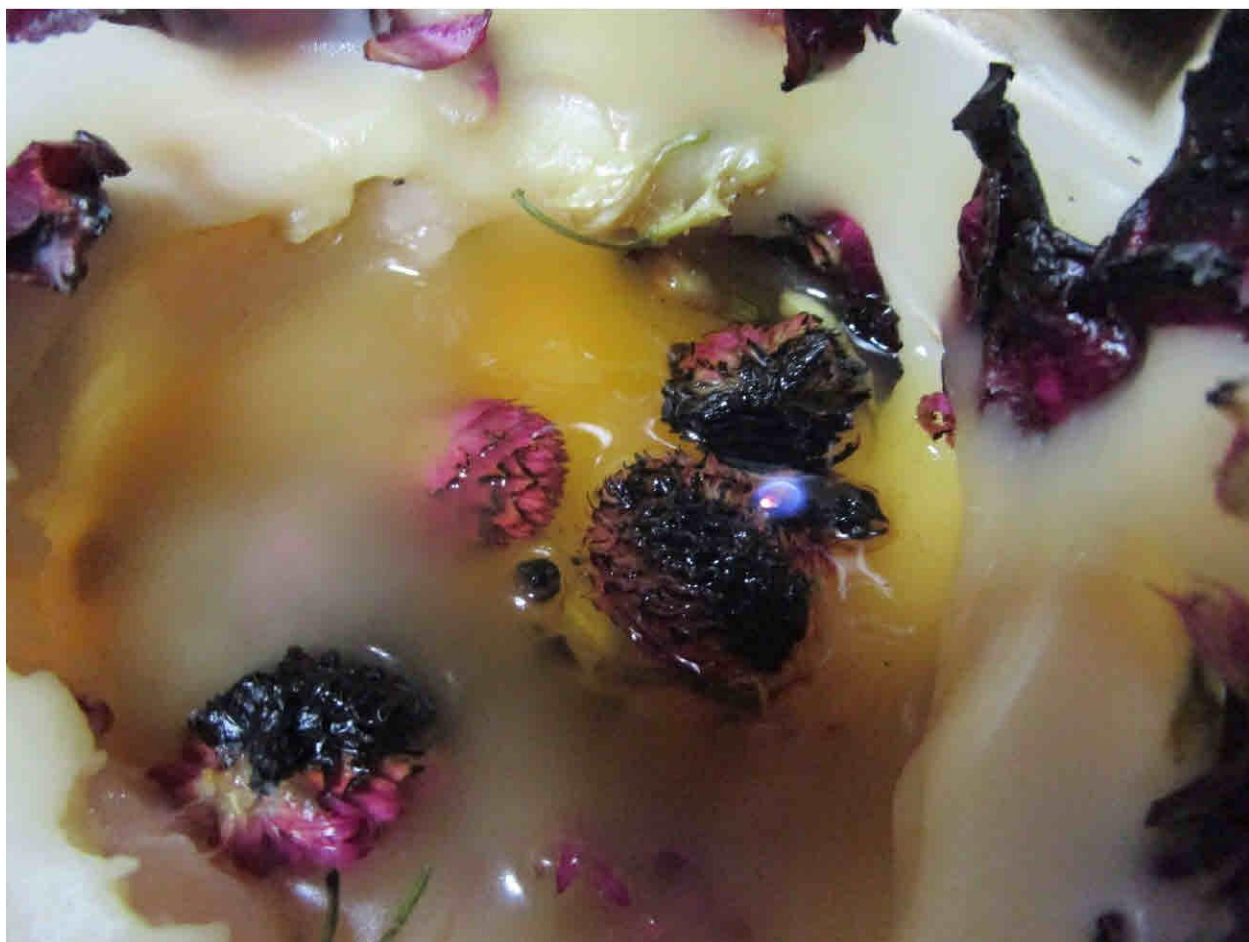
Figure 8: Thirty minutes after lighting Sample 3 Company candle last time. Only botanicals remain lit and wax pool drowns out flame on wick.
