June 17, 2022

Re: **Test Report**  
**Coated and Botanical Candles**  
**Candles Manufactured for Testing Purposes Only**  
**by NCA Member Companies**

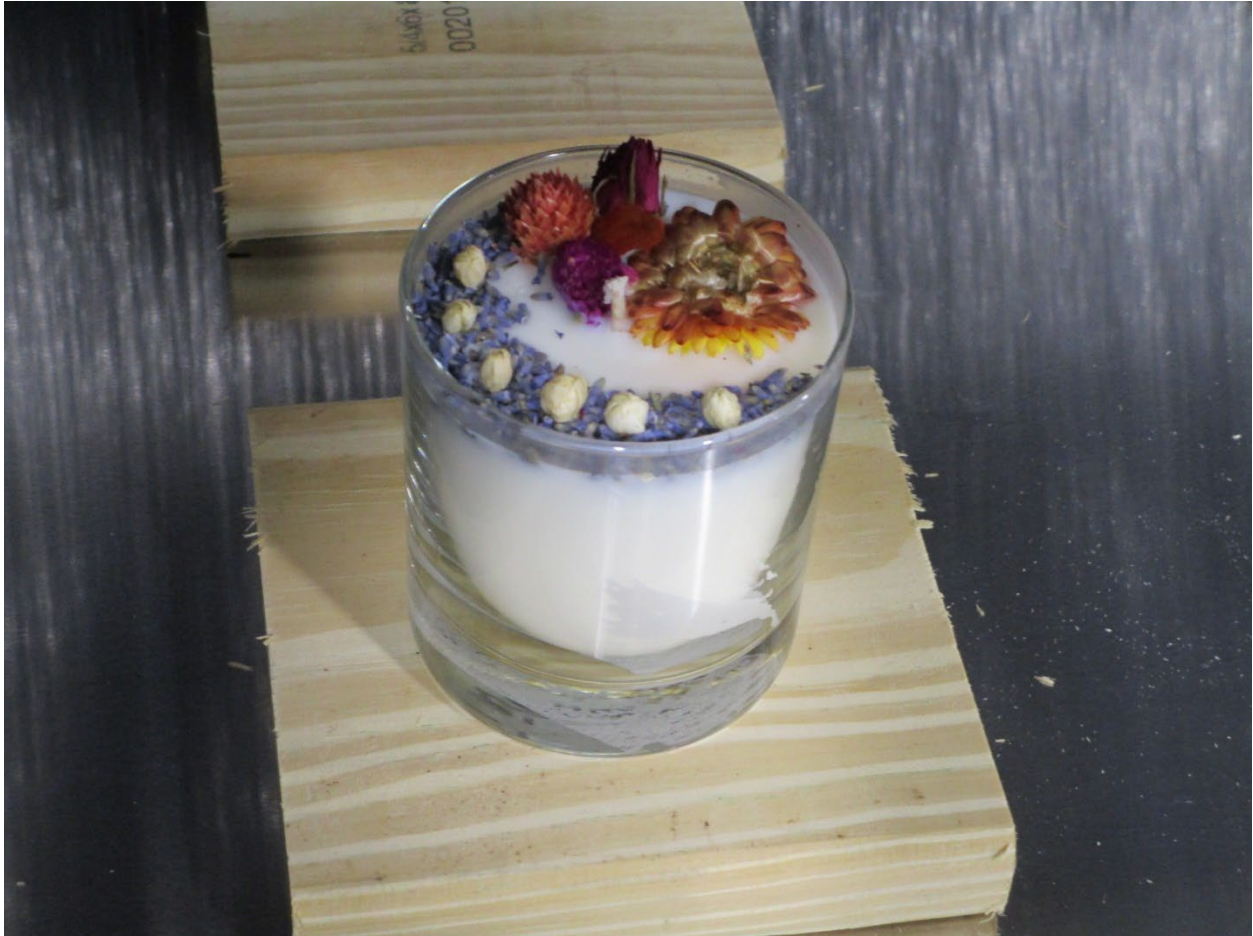
**Figure 1:** Photograph of candle supplied by Renegade Candle Company for testing.

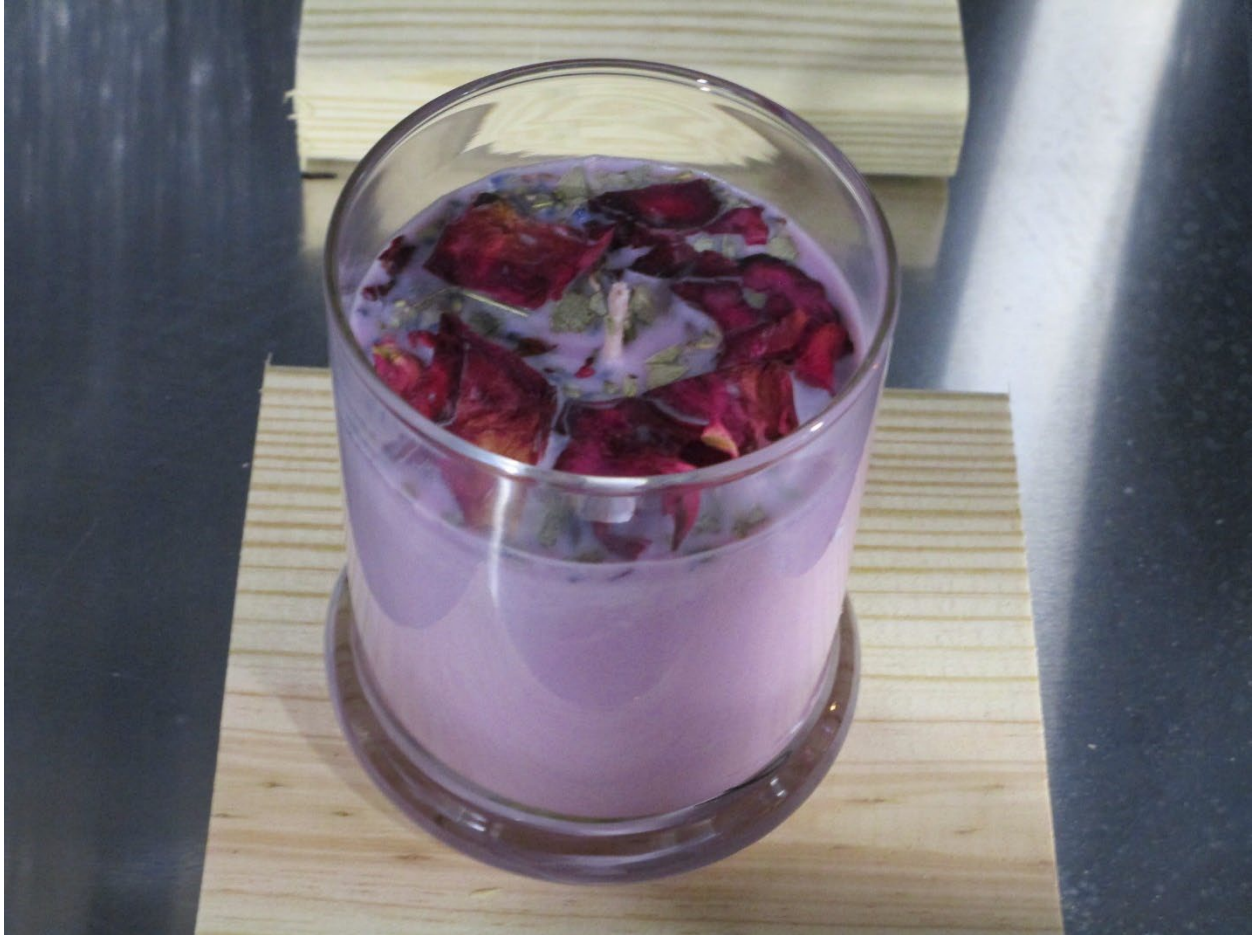
Sample 2: This candle was manufactured for testing only by the Root Candle Company. The candle was a single-wick candle in a glass container, with botanical material on the surface. This candle was burned in four-hour burn cycles in accordance with ASTM F-2417. No secondary ignition events were observed throughout the candle’s burn life.

**Figure 2:** Photograph of candle supplied by Root Candle Company for testing.

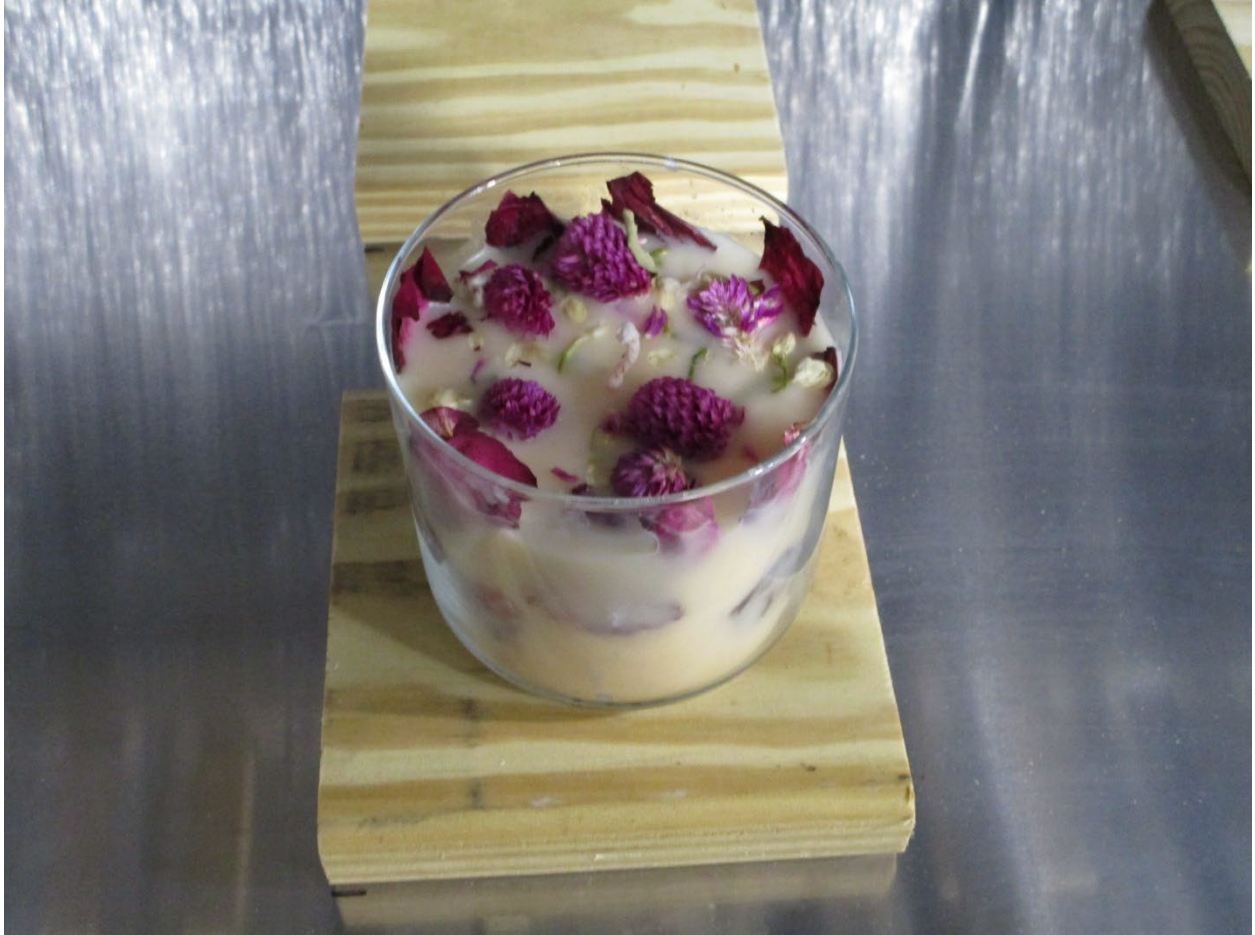
**Figure 3:** Photograph of candle supplied by Candle-Lite Company for testing.

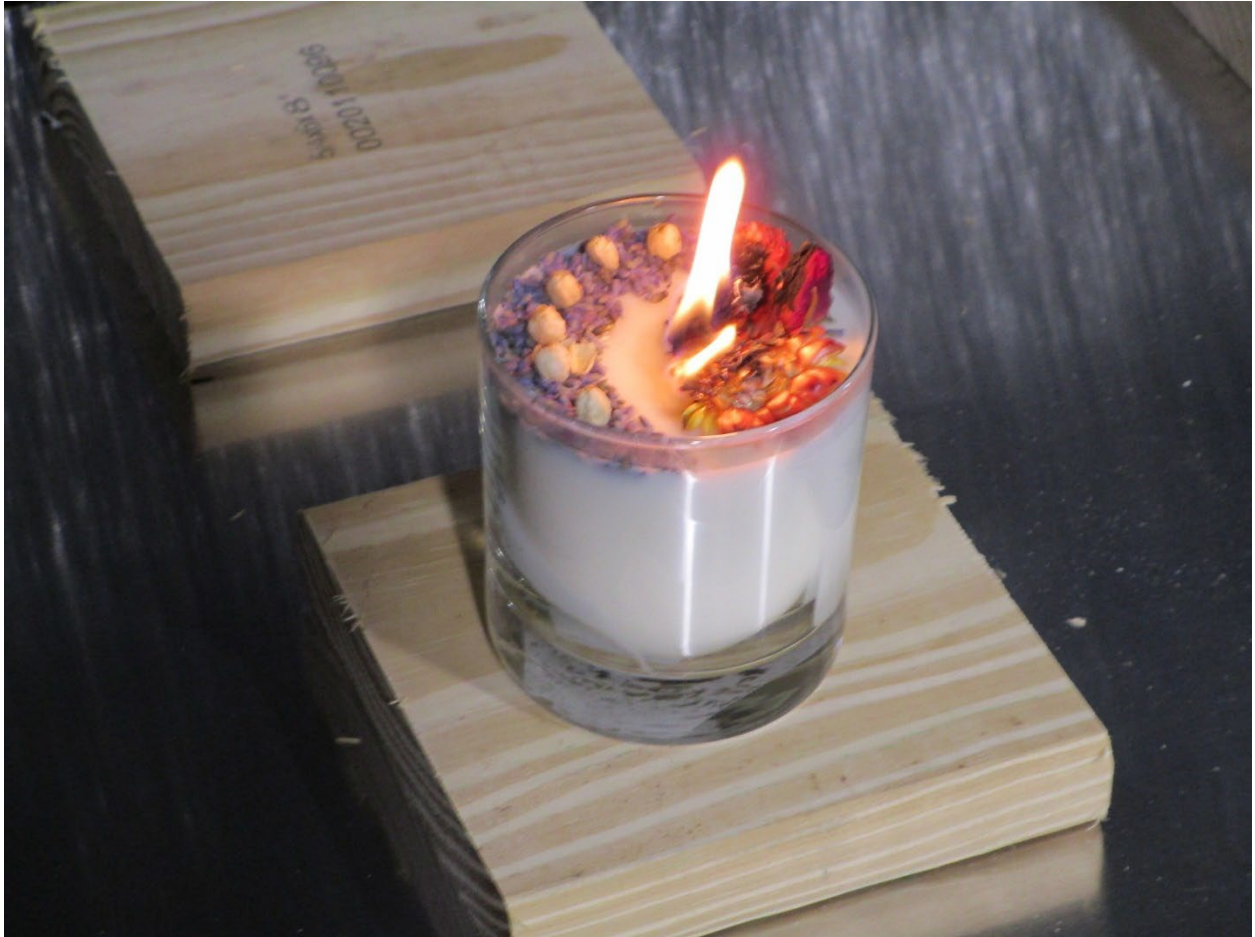
Sample 1: This candle was manufactured for “testing only” by the Renegade Candle Company. The candle consisted of a filled candle, with dried botanical material on the surface. There were flower petals within close proximity of the candle’s wick, such that it was nearly impossible not to light the botanicals when lighting the candle. Figure 1 documents what the candle looked like prior to testing. Shortly after the candle was lit, the botanical features ignited and acted as a secondary ignition source. Within the first hour of the candle burning, the wax had become so hot from the secondary ignition of the botanicals that the wax itself ignited and the candle experienced a flashover event. **Figure 4** shows the beginnings of the secondary ignition of the candle shortly after it was lit. **Figure 5** documents the progression of the secondary ignition event. **Figure 6** documents the candle once it had flashed over and the entire surface of the wax was on fire.

**Figure 4:** Renegade Candle Company candle shortly after lighting. Dried flower has ignited and is supporting combustion.

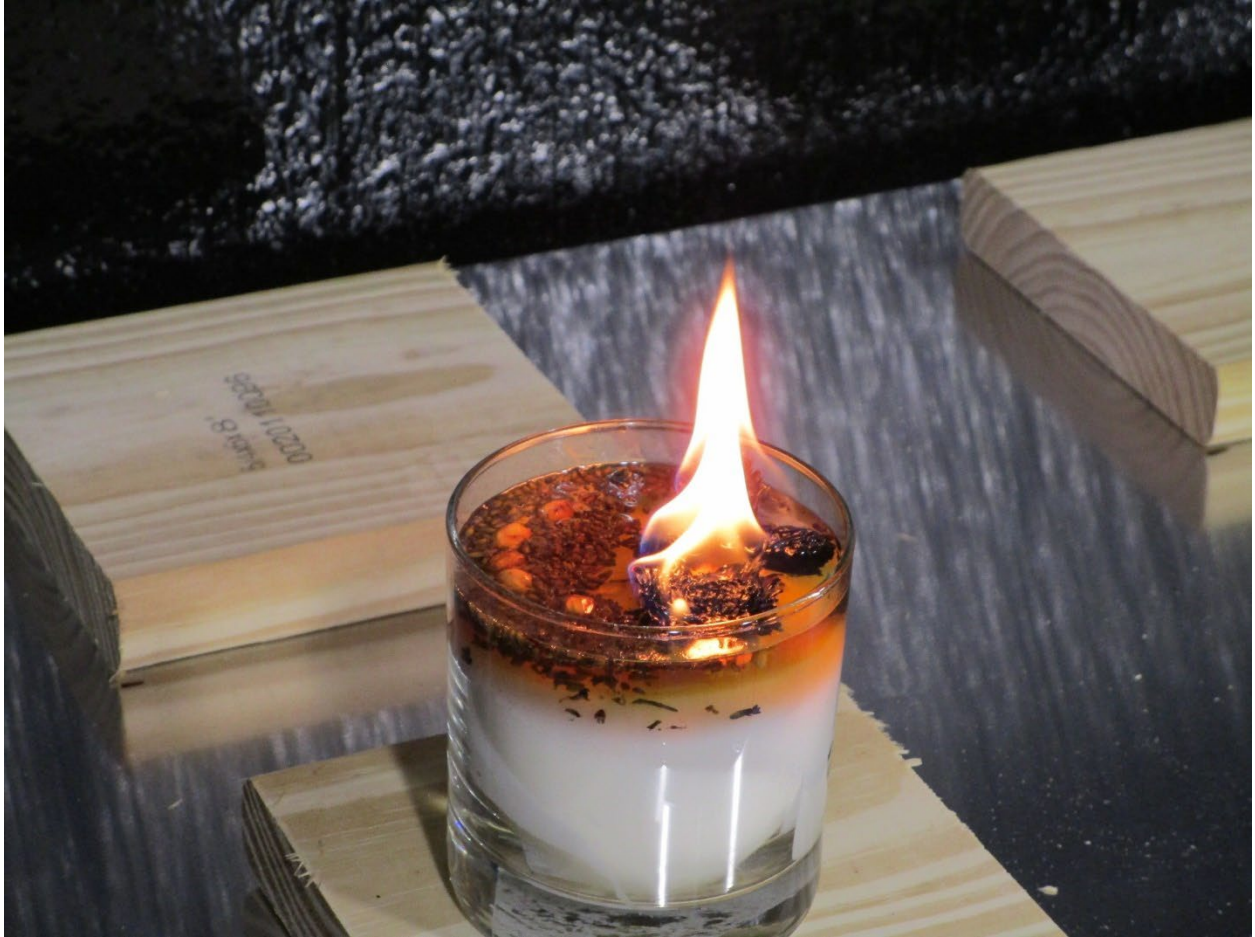
**Figure 5:** Renegade Candle Company candle with secondary ignition progressing. Wax pool is becoming deep.

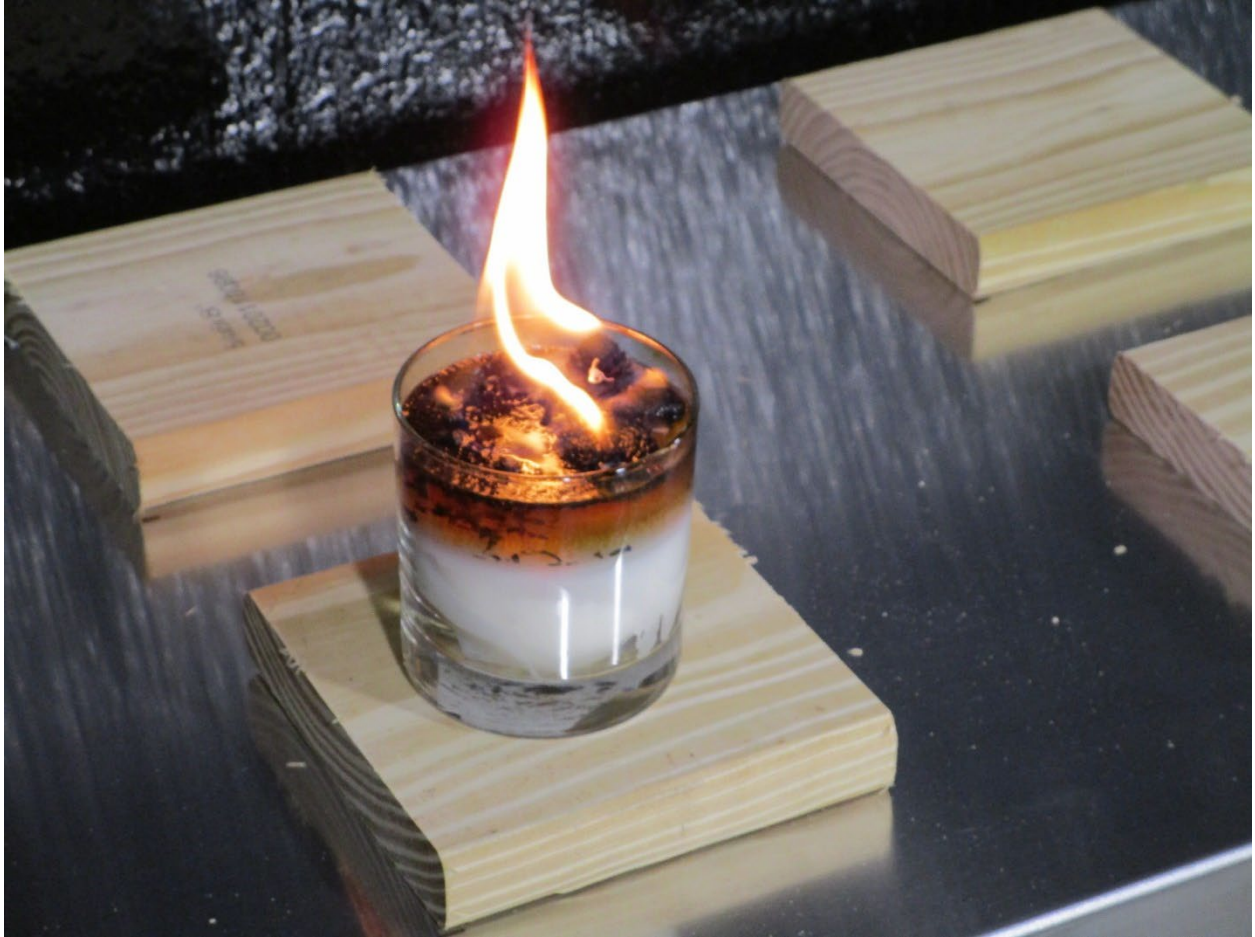
One of the secondary ignition events, specifically the one observed on the candle produced by the Renegade Candle Company for this experiment, was so intense that it caused the candle to experience a flashover event where the entire surface of the wax ignited.

**Figure 6:** Renegade Candle Company candle. Within 50 minutes of lighting, candle experienced flashover where entire surface is on fire.

It should be further noted that when a candle experiences a flashover event, such as sample 1, the addition of water to extinguish the candle fire can create a much worse situation. When water is added to a candle fire, it is like adding water to a grease fire. When the water hits the flaming hot wax, it vaporizes, which creates large flames that are carried with the steam that is emitted due to the addition of water to the candle fire. Should a candle experience a flashover, the safest way to extinguish the fire is to smother it with a pot or some other device and starve the fire of oxygen. For safety reasons, a candle flashover event should never be extinguished with water.

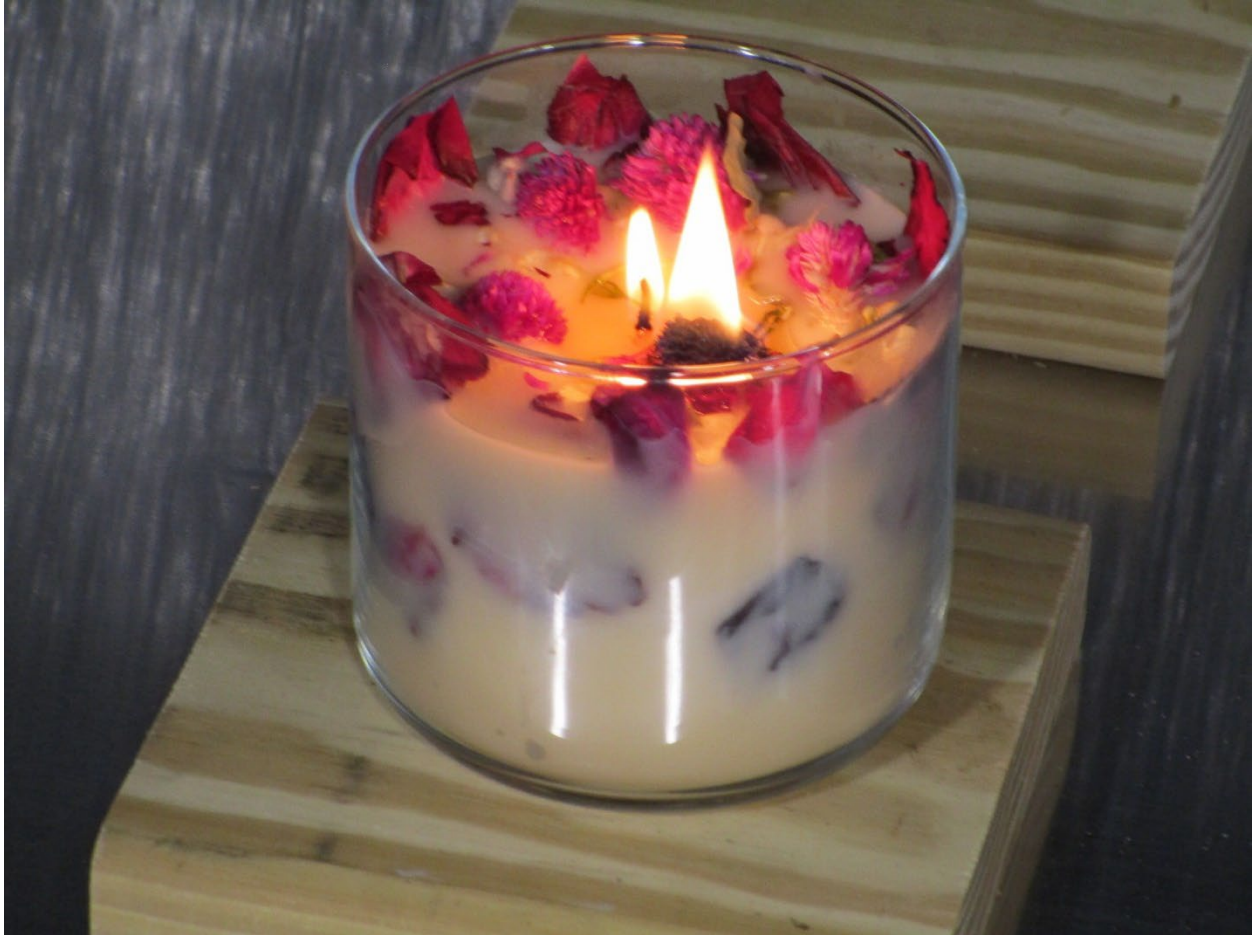
Sample 3: This candle was manufactured for testing only by the Candle-Lite Company and was also a single-wick candle in a glass container, with botanical materials on the surface and imbedded in the candle wax, as seen in Figure 3. This candle experienced a secondary ignition event of the botanical materials the first time the candle was burned. **Figure 7** documents this secondary ignition event. Testing of the candle continued, and the candle was burned in four-hour burn cycles per the ASTM F-2417 test method. The candle continued to experience secondary ignition events as it burned; however, it did not experience a flashover event. The candle’s wick eventually drowned, as the secondary ignition of botanicals in the candle created a large melt pool causing the flame on the primary wick to extinguish. **Figure 8** shows the candle when the primary wick was drowned out and only the botanical material remained lit.

**Figure 7:** Candle-Lite Company candle, with secondary ignition of botanicals, during first four-hour burn cycle.

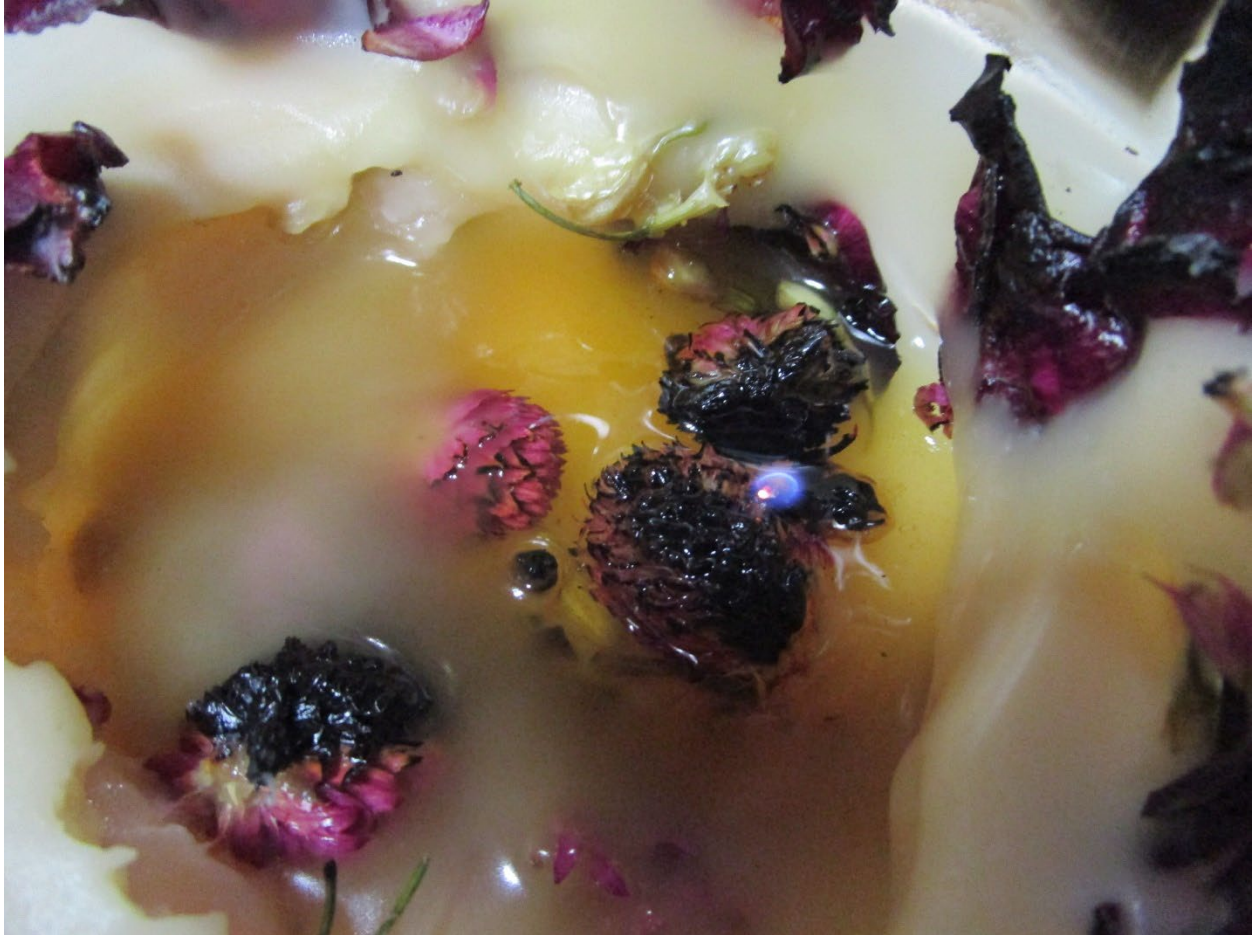
**Figure 8:** Thirty minutes after lighting Candle-Lite Company candle last time. Only botanicals remain lit and wax pool drowns out flame on wick.
